# EXPERIMENTAL TESTING UPON THE INTEGRATED SYSTEM OF EMMEDUE MODULAR PANELS

REPORT ON STATIC TESTING FOR PANELS OF REDUCED DIMENSIONS

EUCENTRE

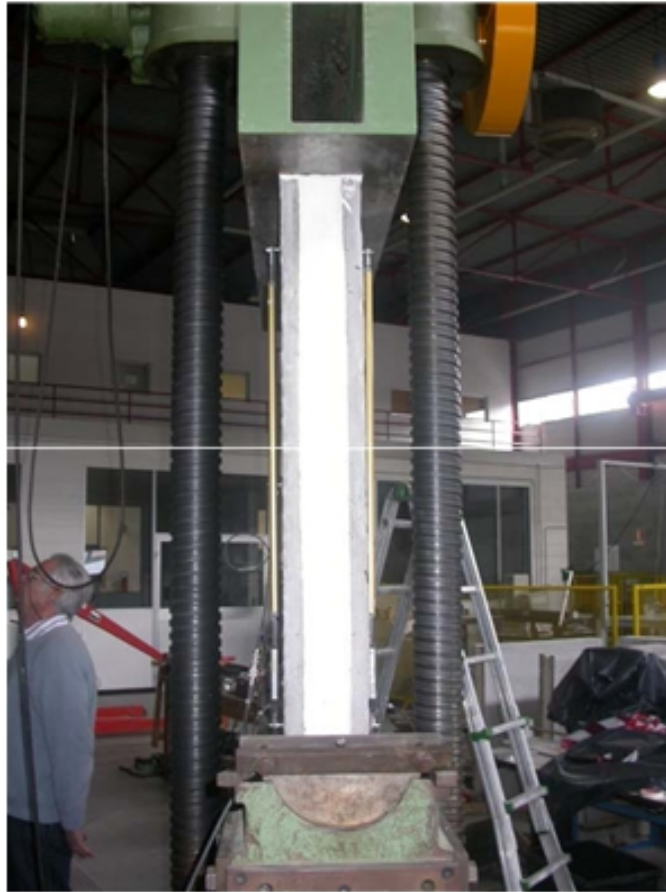
For the compression testing, after having smoothed the panel in order to normalize the support surface, the load was applied in a uniform manner.

Figure 2: Compression test

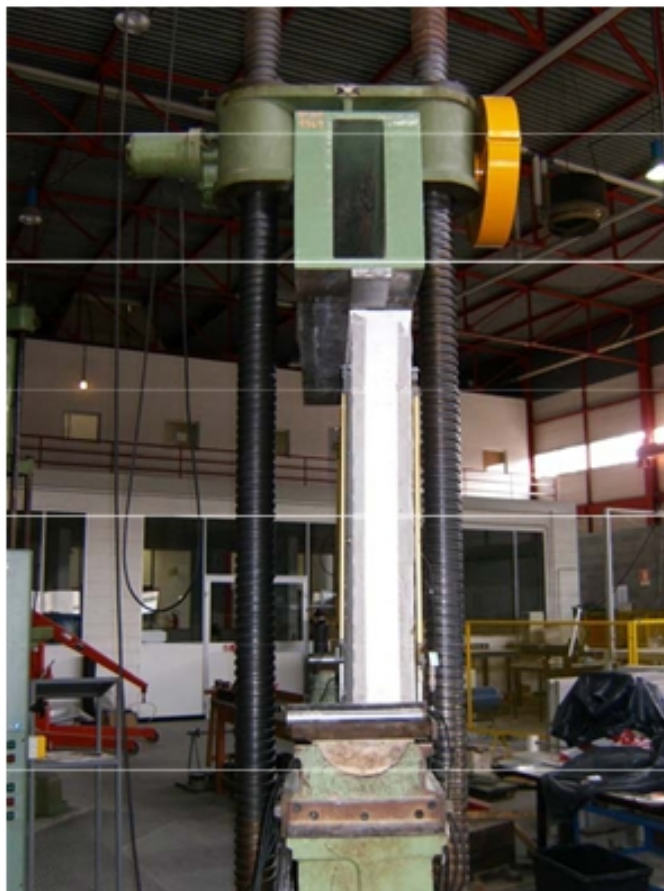
For the eccentric compression testing, after having smoothed the panel in order to normalize the support surface, the load was only applied to half the thickness.

Figure 4: Eccentric compression test

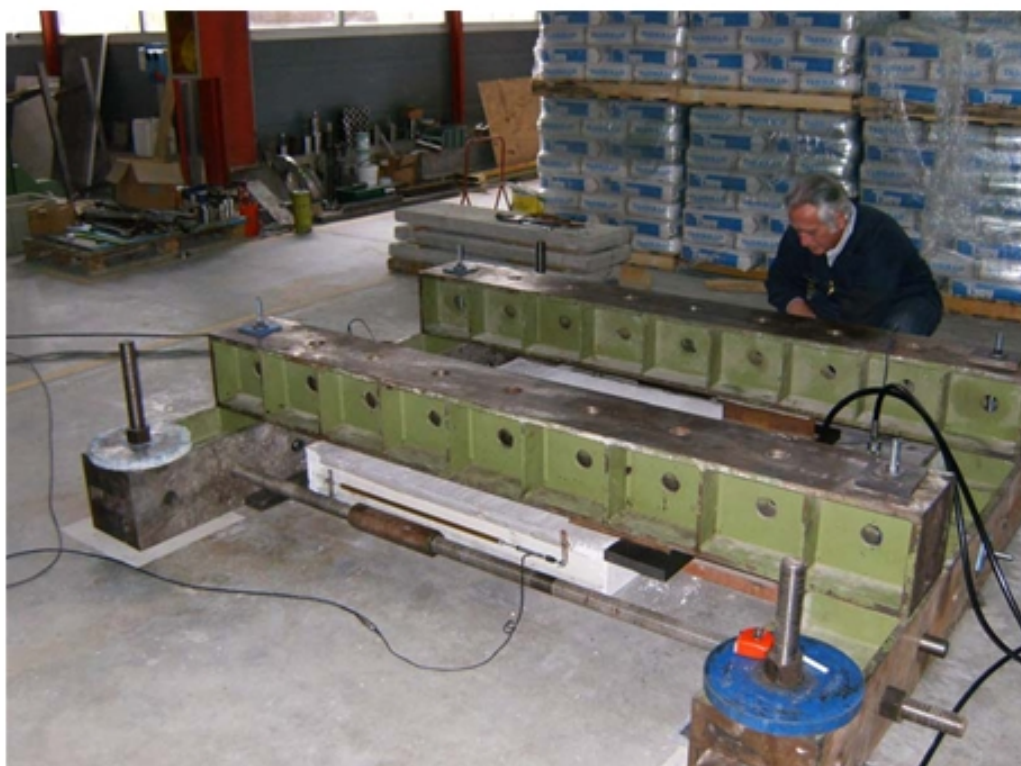
For the delamination testing, a testing station was realized, shown in figure 5 below, in order to apply the load exclusively to a single layer of concrete and to check the other layer, thereby allowing the polystyrene to slide.

Figure 5: Delamination test

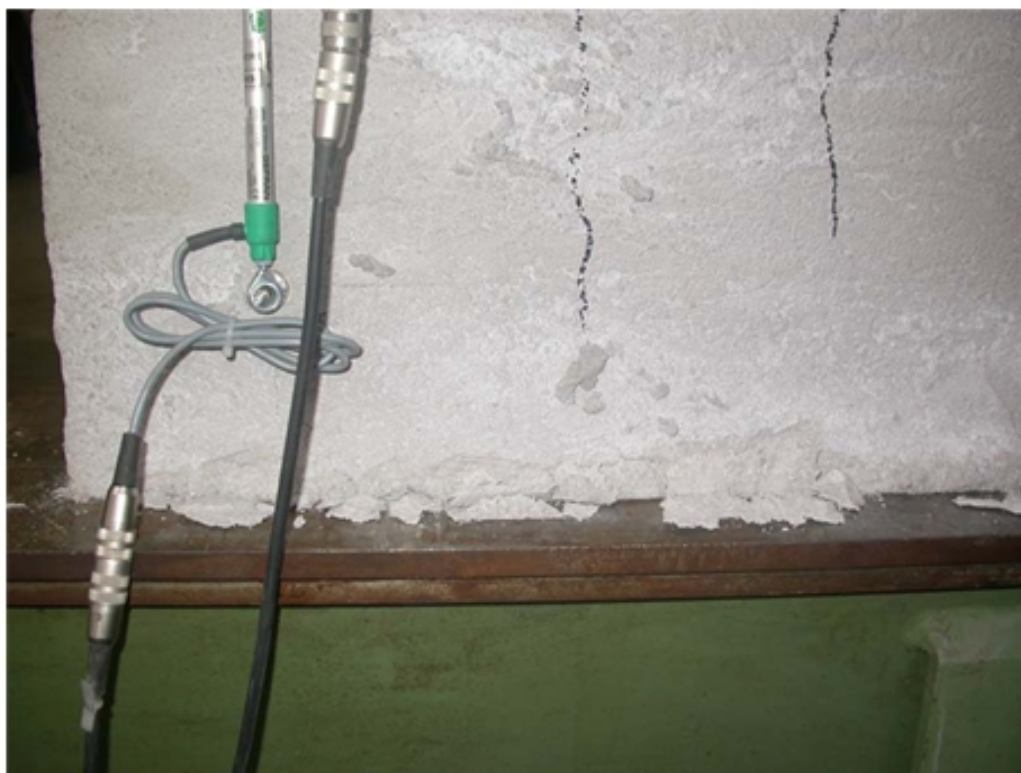
Localized breakage occurred as a result of not having performed the smoothing

Figure 11: Localized breakage

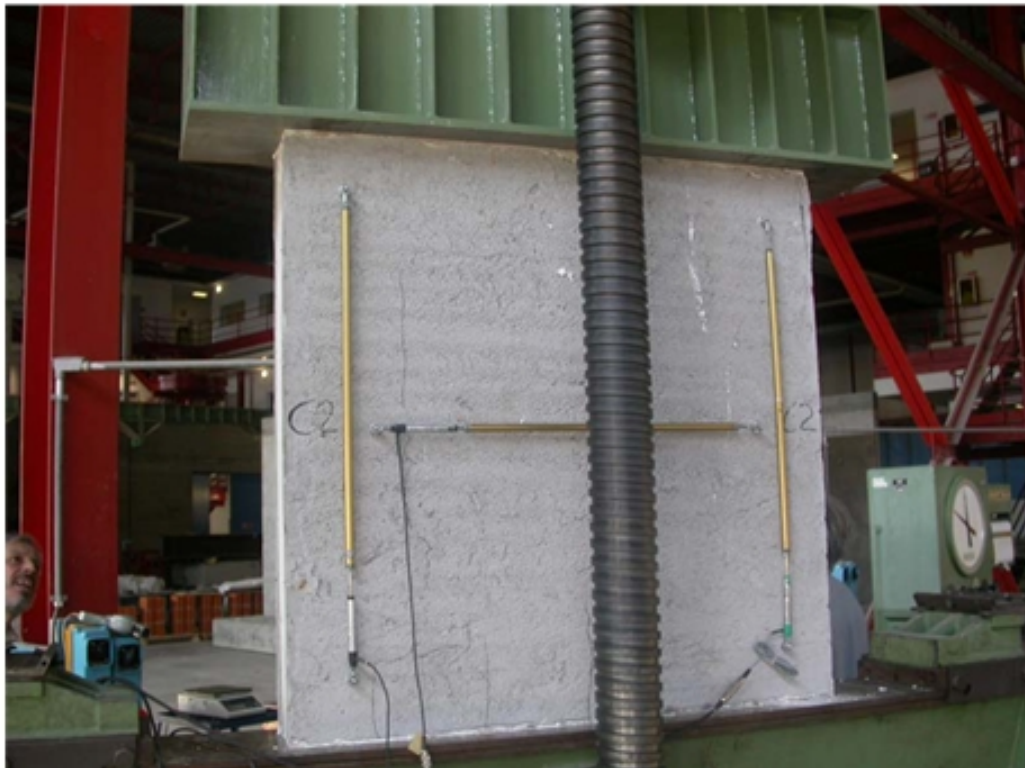
Figure 12: Edge breakage

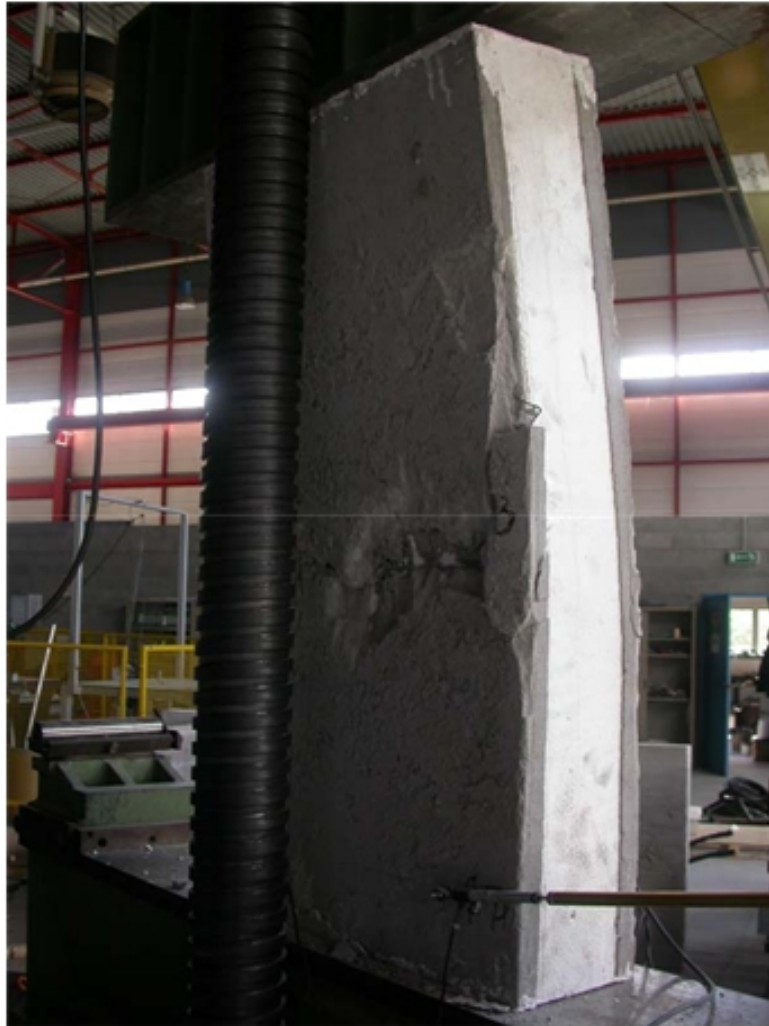
Figure 13: Breakage due to compression and flexion stresses

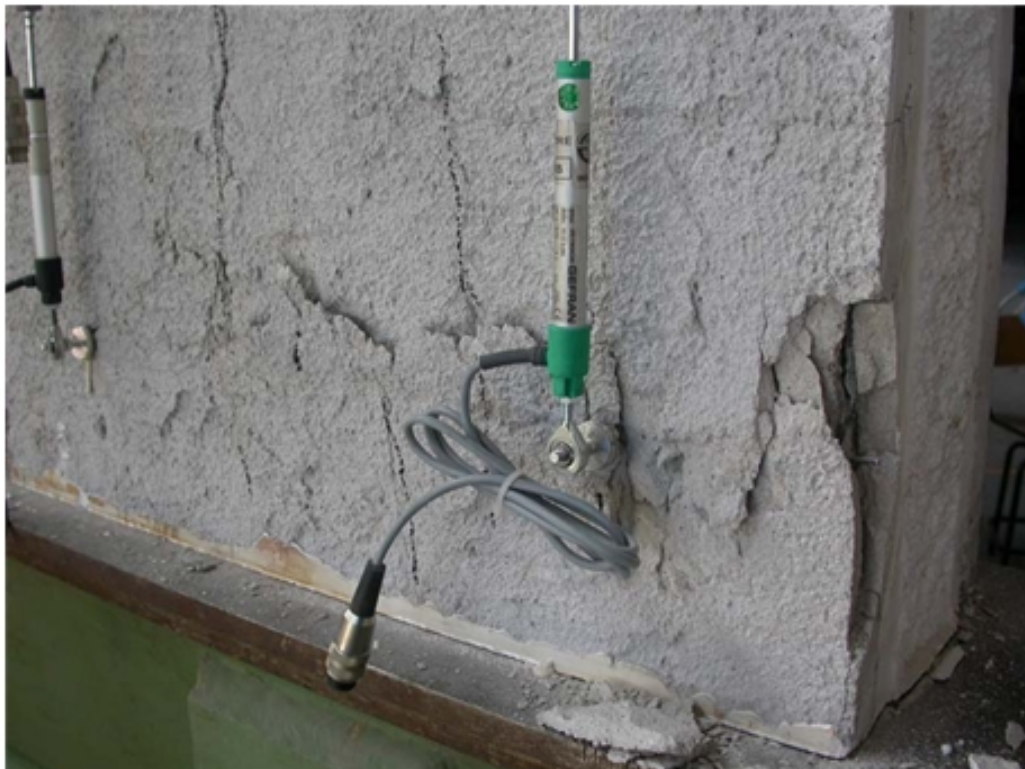
Figure 15: Breakage due to cement compression

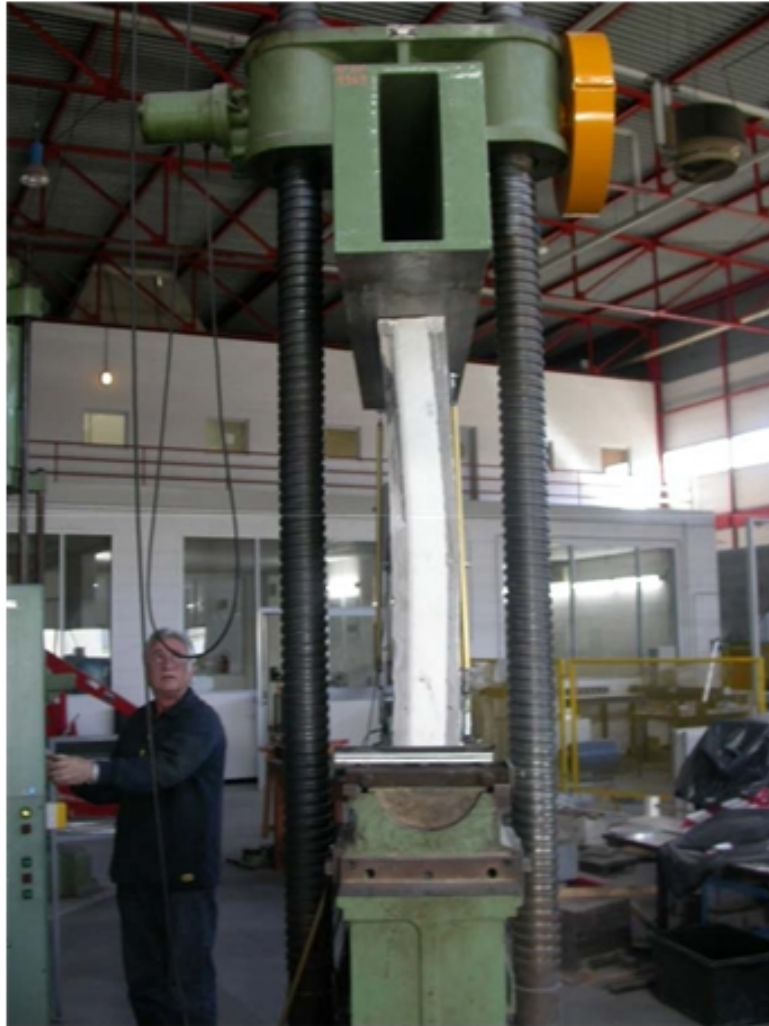
Figure 16: Destabilization of the sample

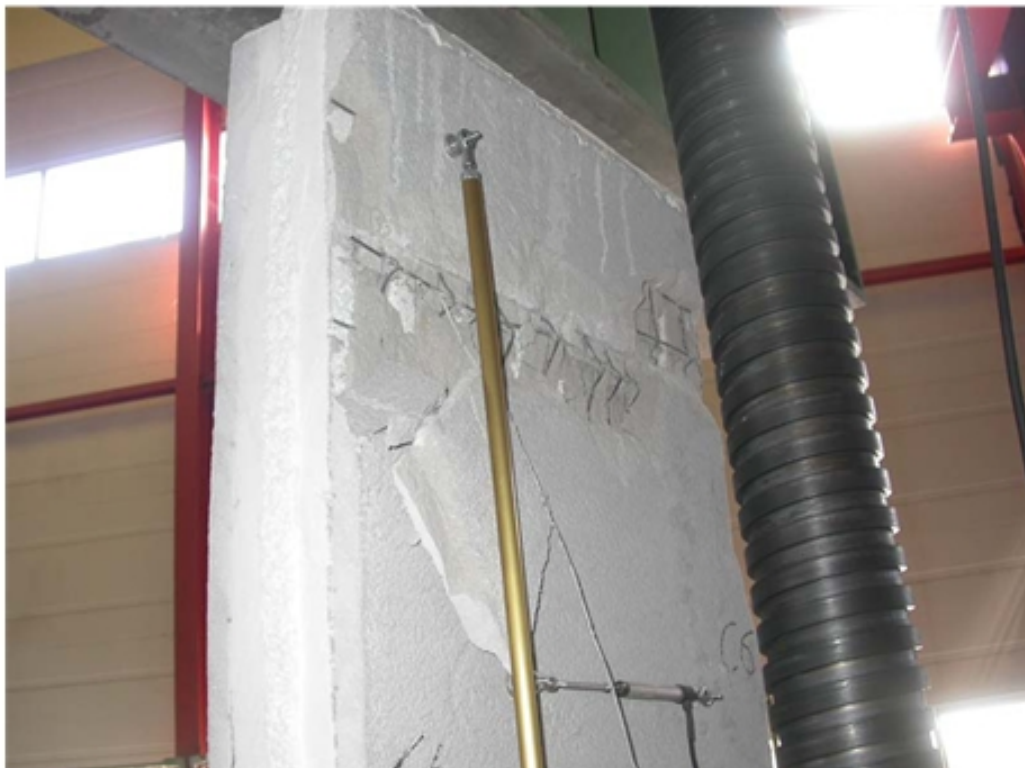
Figure 17: Destabilization of the compressed reinforcement

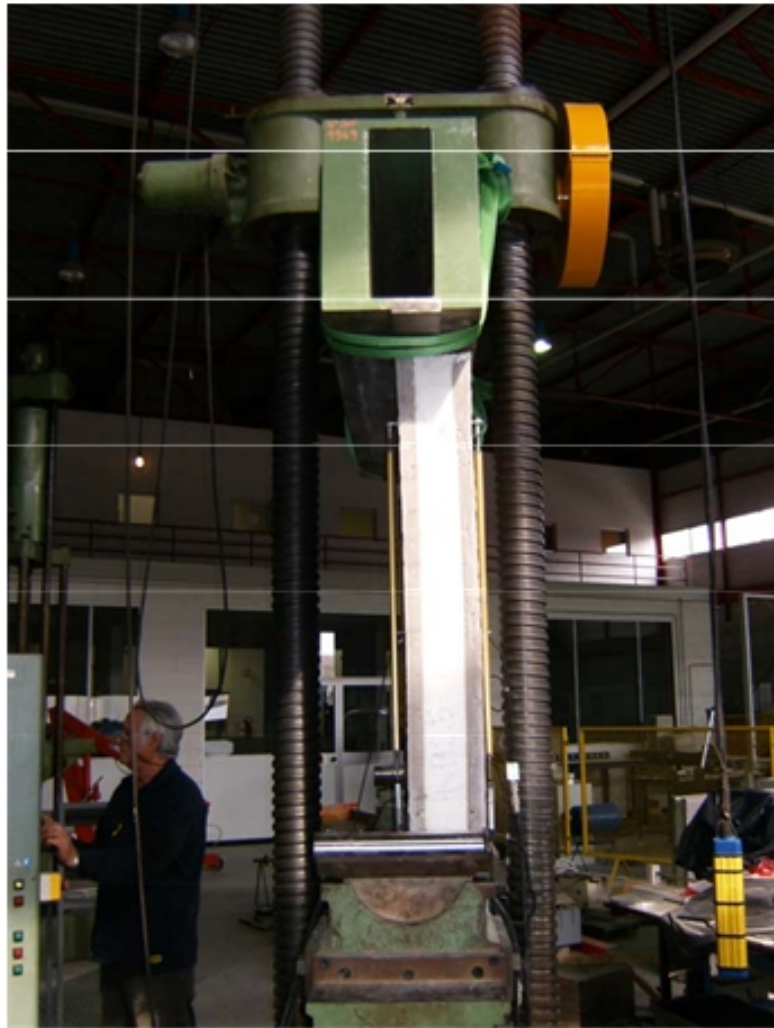
Figure 20: Application of the load

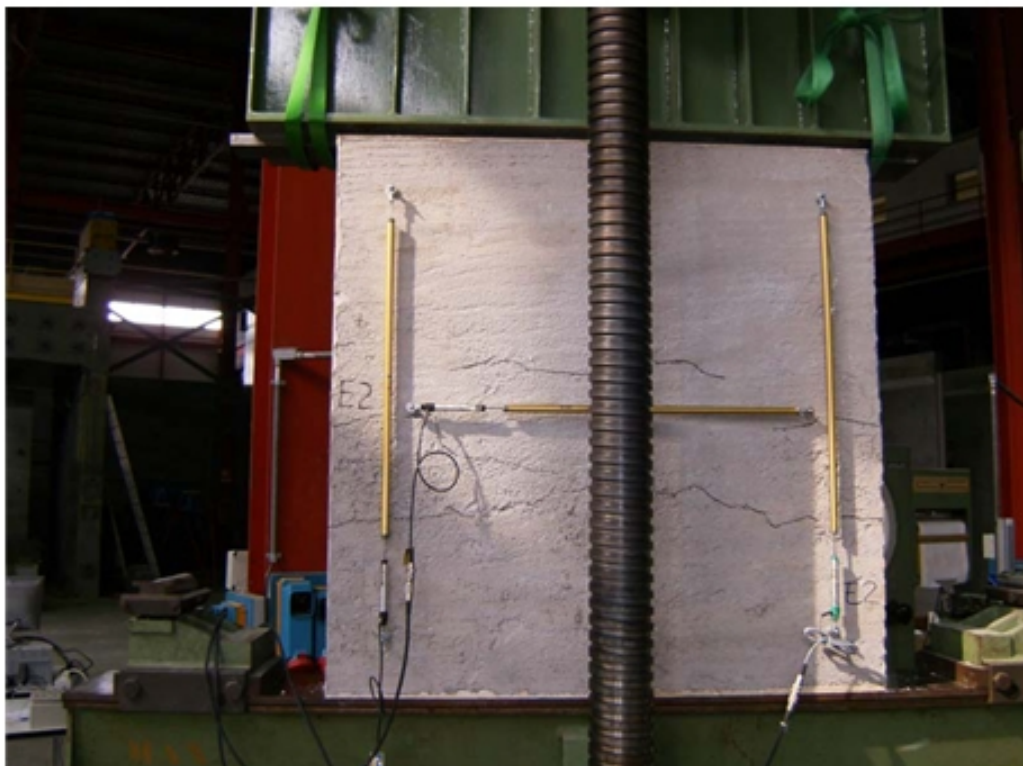
Figure 21: Fissure summary during testing

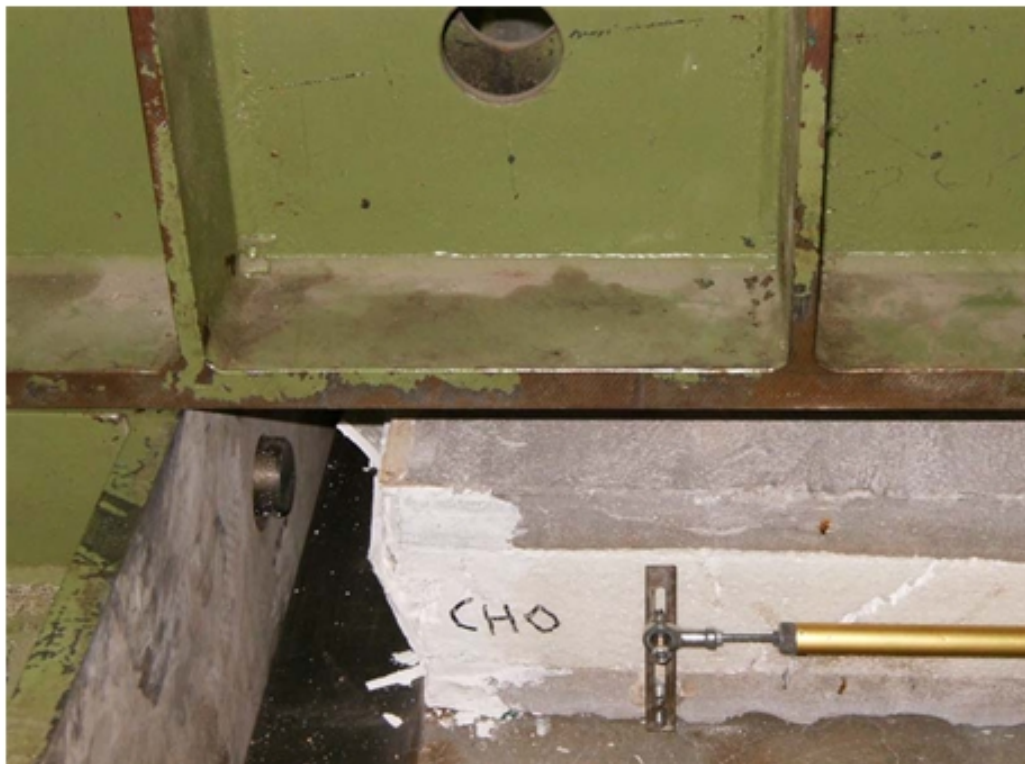
Figure 22: Sliding of the polystyrene slab

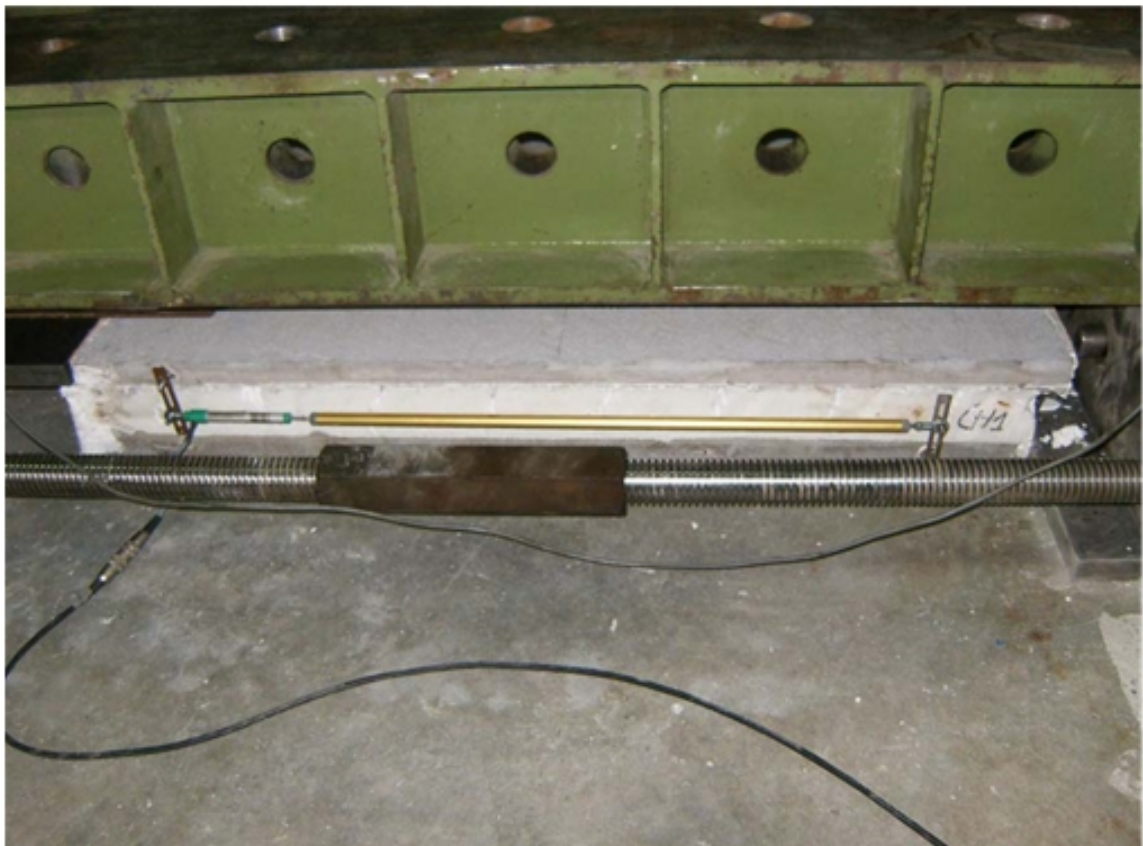
Figure 23: Sliding of the polystyrene slab

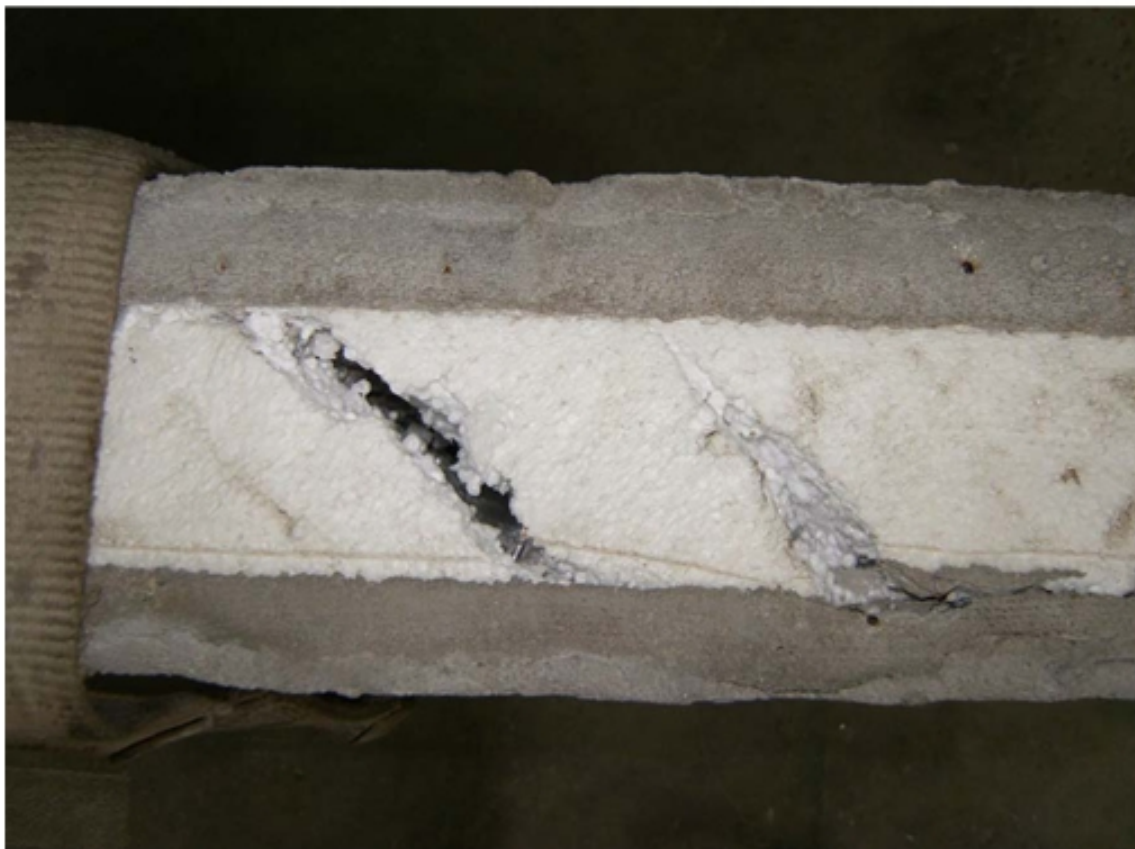
Figure 24: Diagonal fissures in the polystyrene
